Summerland Well Research Project Phase I Report

June 20, 2000

Phase I Project Report

Phase II-A Report

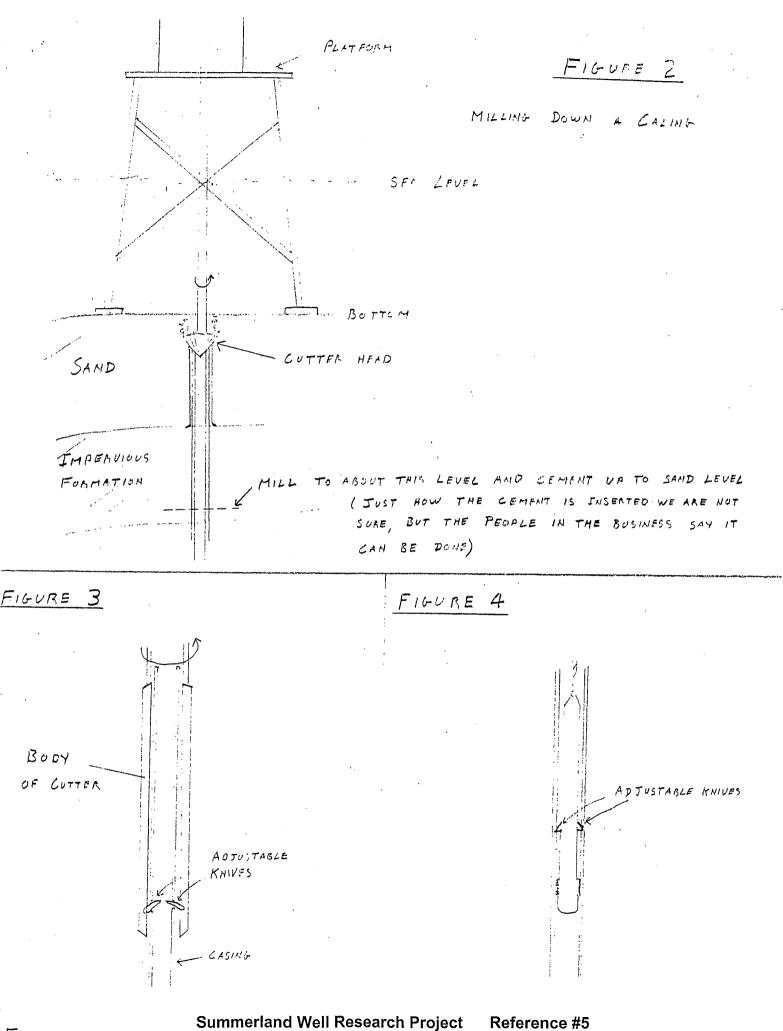
DIAGI 1 OF TYPICAL OLD W L

In order to completely close off a well it would be necessary to build a platform over the well and mill away the casing down into solid rock. (See fig. 2) Then the hole could be cemented and the well completely sealed off. The reason for milling and cementing below the top of the first rock level is to prevent seepage between the casing and drill hole, or between concentric casings. The cost per well of doing the job by this technique is estimated to be about \$10,000 for wells in or seaward of the surfline and perhaps half that for wells on the beach.

The old wells in the Summerland area generally have two concentric casings and some have three. The thickness of individual casings varies up to - inch. Rods and tubes are occasionally present within the inner casings. Most, if not all of the casings, including the spaces between concentric casings, are packed with sand, rocks, rust, tar, and other debris. Fuch of the metal is in poor condition. A large percentage of the casings are bent, twisted, or otherwise deformed. Casings beyond the surfline are heavily encrusted with marine growth.

- (3) Open up internal casings, put in short cement plugs, and shoot off all casings just above the plus with an internal bulk charge. The cement plug must not have set before the charge is fired! Projecting or damaged casings will often have to be shot off first with external shaped charges in order to get at and open up the internal casing. This method will prevent any of the casings worked on from again protruding and will stop a large part of the seepage. (See fig. 5) Estimated cost: \$1,500.

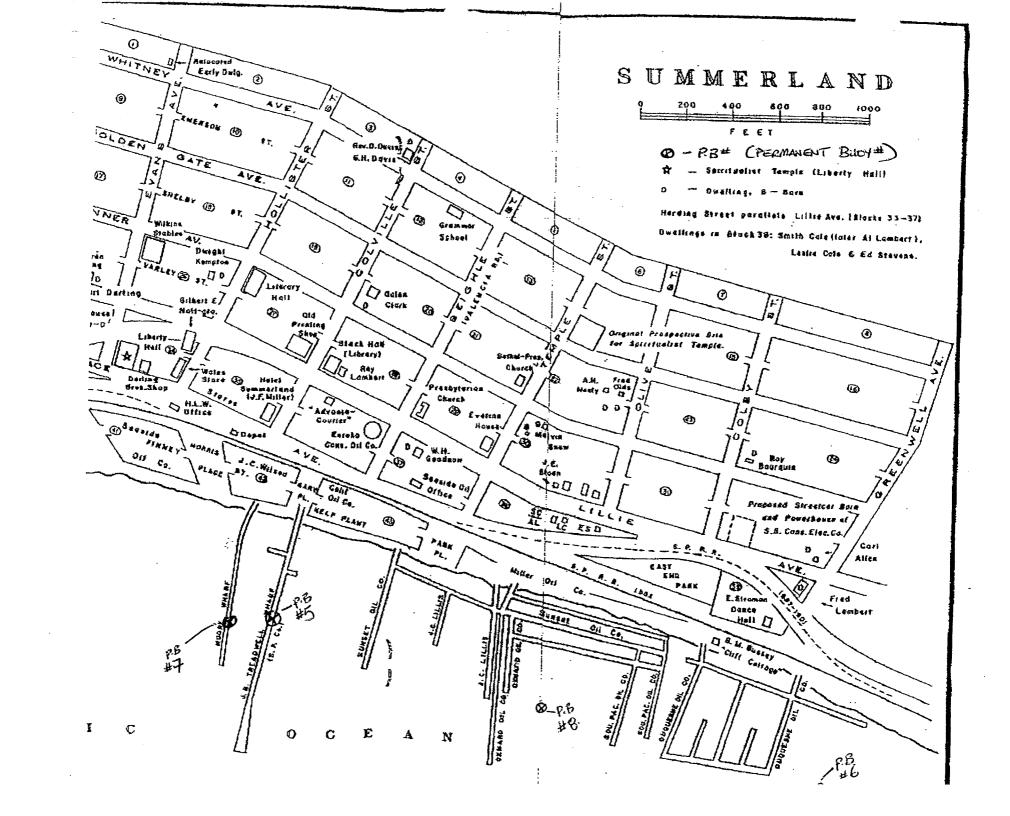
Para Chin Har in Anna
BOTTOM CONDITION HERE IS A MIXTURE
OF SAND TO THE GAST, THE REST
BEING ROCK WITH SCATTERED CLUMPS
OF KELP AND GROWTH. BOTTOM CONTOUR
VARIES, 1'TOZ' AT THIS LOCATION.
0,40,000
1) STEEL PLATE BURIED IN THE SAND,
WITH APPROXIMATELY 2"-3" OF EDGE
SHOWING UP OUT OF THE SEABLED.
The state of the s
6 20' To To Computer is a 20"
(3) 20' TO THE SOUTHWEST IS A 72"
Diameter Steel CASING. /TIS FILLED
Win A CONCRETE PLUG. DIE SEEPAGE
IS OBSERVED LEAKING THROUGH THE
PLUG, AROUND THE NORTH EDGE AND
UP TO A FOOT OR SO AWAY, COMING
UP THROUGH ROCKS ON THE BOTTOM!
GAS BUBBLES ALSO VISIBLE-Cominy
UP THOUGH A SEAM OF THE CASING-
W 5-12 D - (10/ 1/- 1/- 1-2)
* SPAR BUOY'C' NOW LOCATED AT THIS
AREA.
•

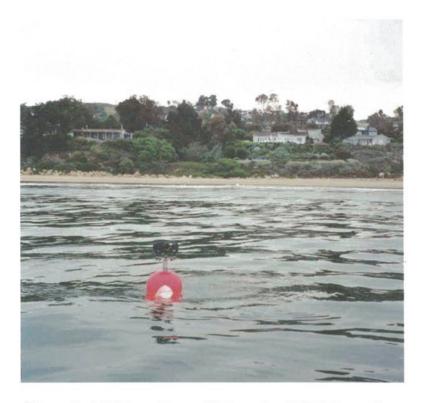
Diver-Held Prism Buoy At Treadwell #10 Location

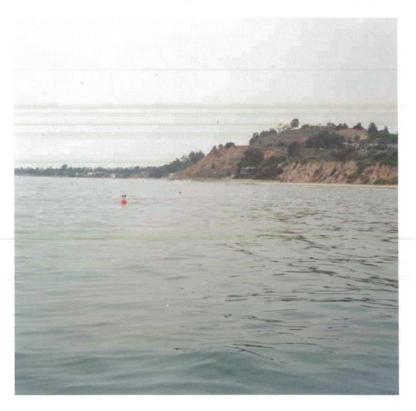
Diver-Held Prism Buoy At Moore Wharf Location

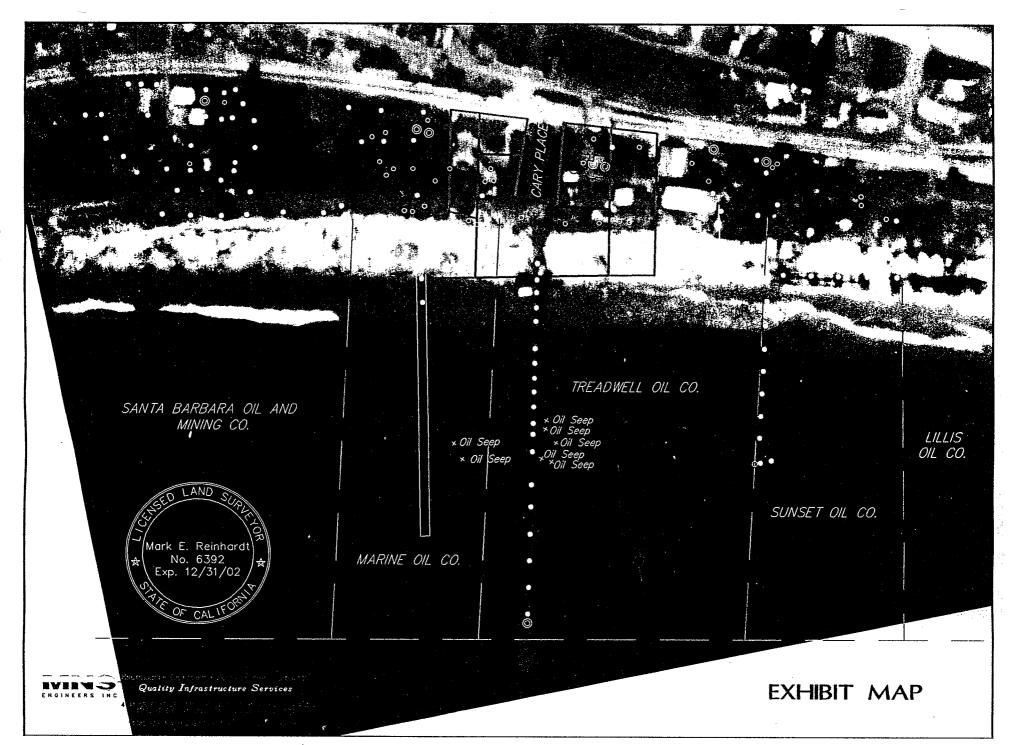
BOTTOM CONDITION HERE IS A MIXTURE
OF SAND TO THE GAST, THE REST
BEING ROCK WITH SCATTERED CLUMPS
OF KELP AND GROWTH. BOTTOM CONTOUR
VARIES, 1'TOZ' AT THIS LOCATION.
·
1) STEEL PLATE BURIED IN THE SAND,
WITH APPROXIMATELY 2"-3" OF EDGE
SHAVING UP OUT OF THE SEABLED.
(2) 20' TO THE SOUTHWEST IS A 72"
DIAMETER STEEL CASING. 17 15 FILLED
With A CONCRETE PLUG. DIE SEEPAGE
IS OBSERVED LEAKING THROUGH THE
PLUG, AROUND THE NORTH EDGE AND
UP TO A FOOT DO SO AWAY, COMING
UP THROUGH ROCKS ON THE BOTTOM.
GAS BUBBLES ALSO VISIBLE-COMING
UP THROUGH A SEAM OF THE CASING-
* SPAR BUOY'C' NOW LOCATED AT THIS
ADEA
//DEA
·
